Incident Investigation Report

Title: HAUV Garage LARS Integration Testing

Project: EA / OGGS Pipeline Inspection survey

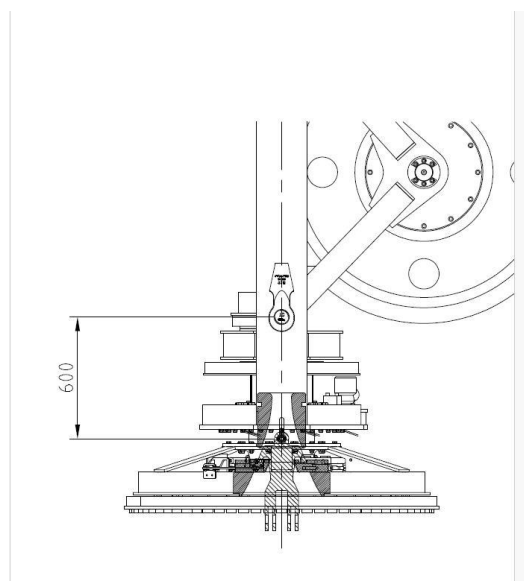
Smd snubber arrangement

The swage of the Steel Wire Rope (SWR) separated during onboarding tests of the manta HAUV garage. Only the LARS umbilical and spelter socket fell to the quayside after striking the LARS A-frame base. The HAUV Garage remained latched in the snubber of the A-frame and suspended around 4-5m above the ground. The garage was safely recovered to the deck of the A-frame and no personnel were injured.

When tension was applied to the umbilical to raise the SMD interface bullet above the snubber, the SWR parted. see diagram below *indicating SMD snubber arrangement*:
